**BOEING 737 9M-MBD—REPORT 1/78
ACCIDENT NEAR GELANG PATAH, NEGERI JOHOR**

**BOEING 737 9M-MBD
REPORT ON THE ACCIDENT AT TANJUNG KUPANG,
GELANG PATAH JOHOR BAHRU,
ON 04 DECEMBER, 1977**

Aircraft Accident Report No: 1/78

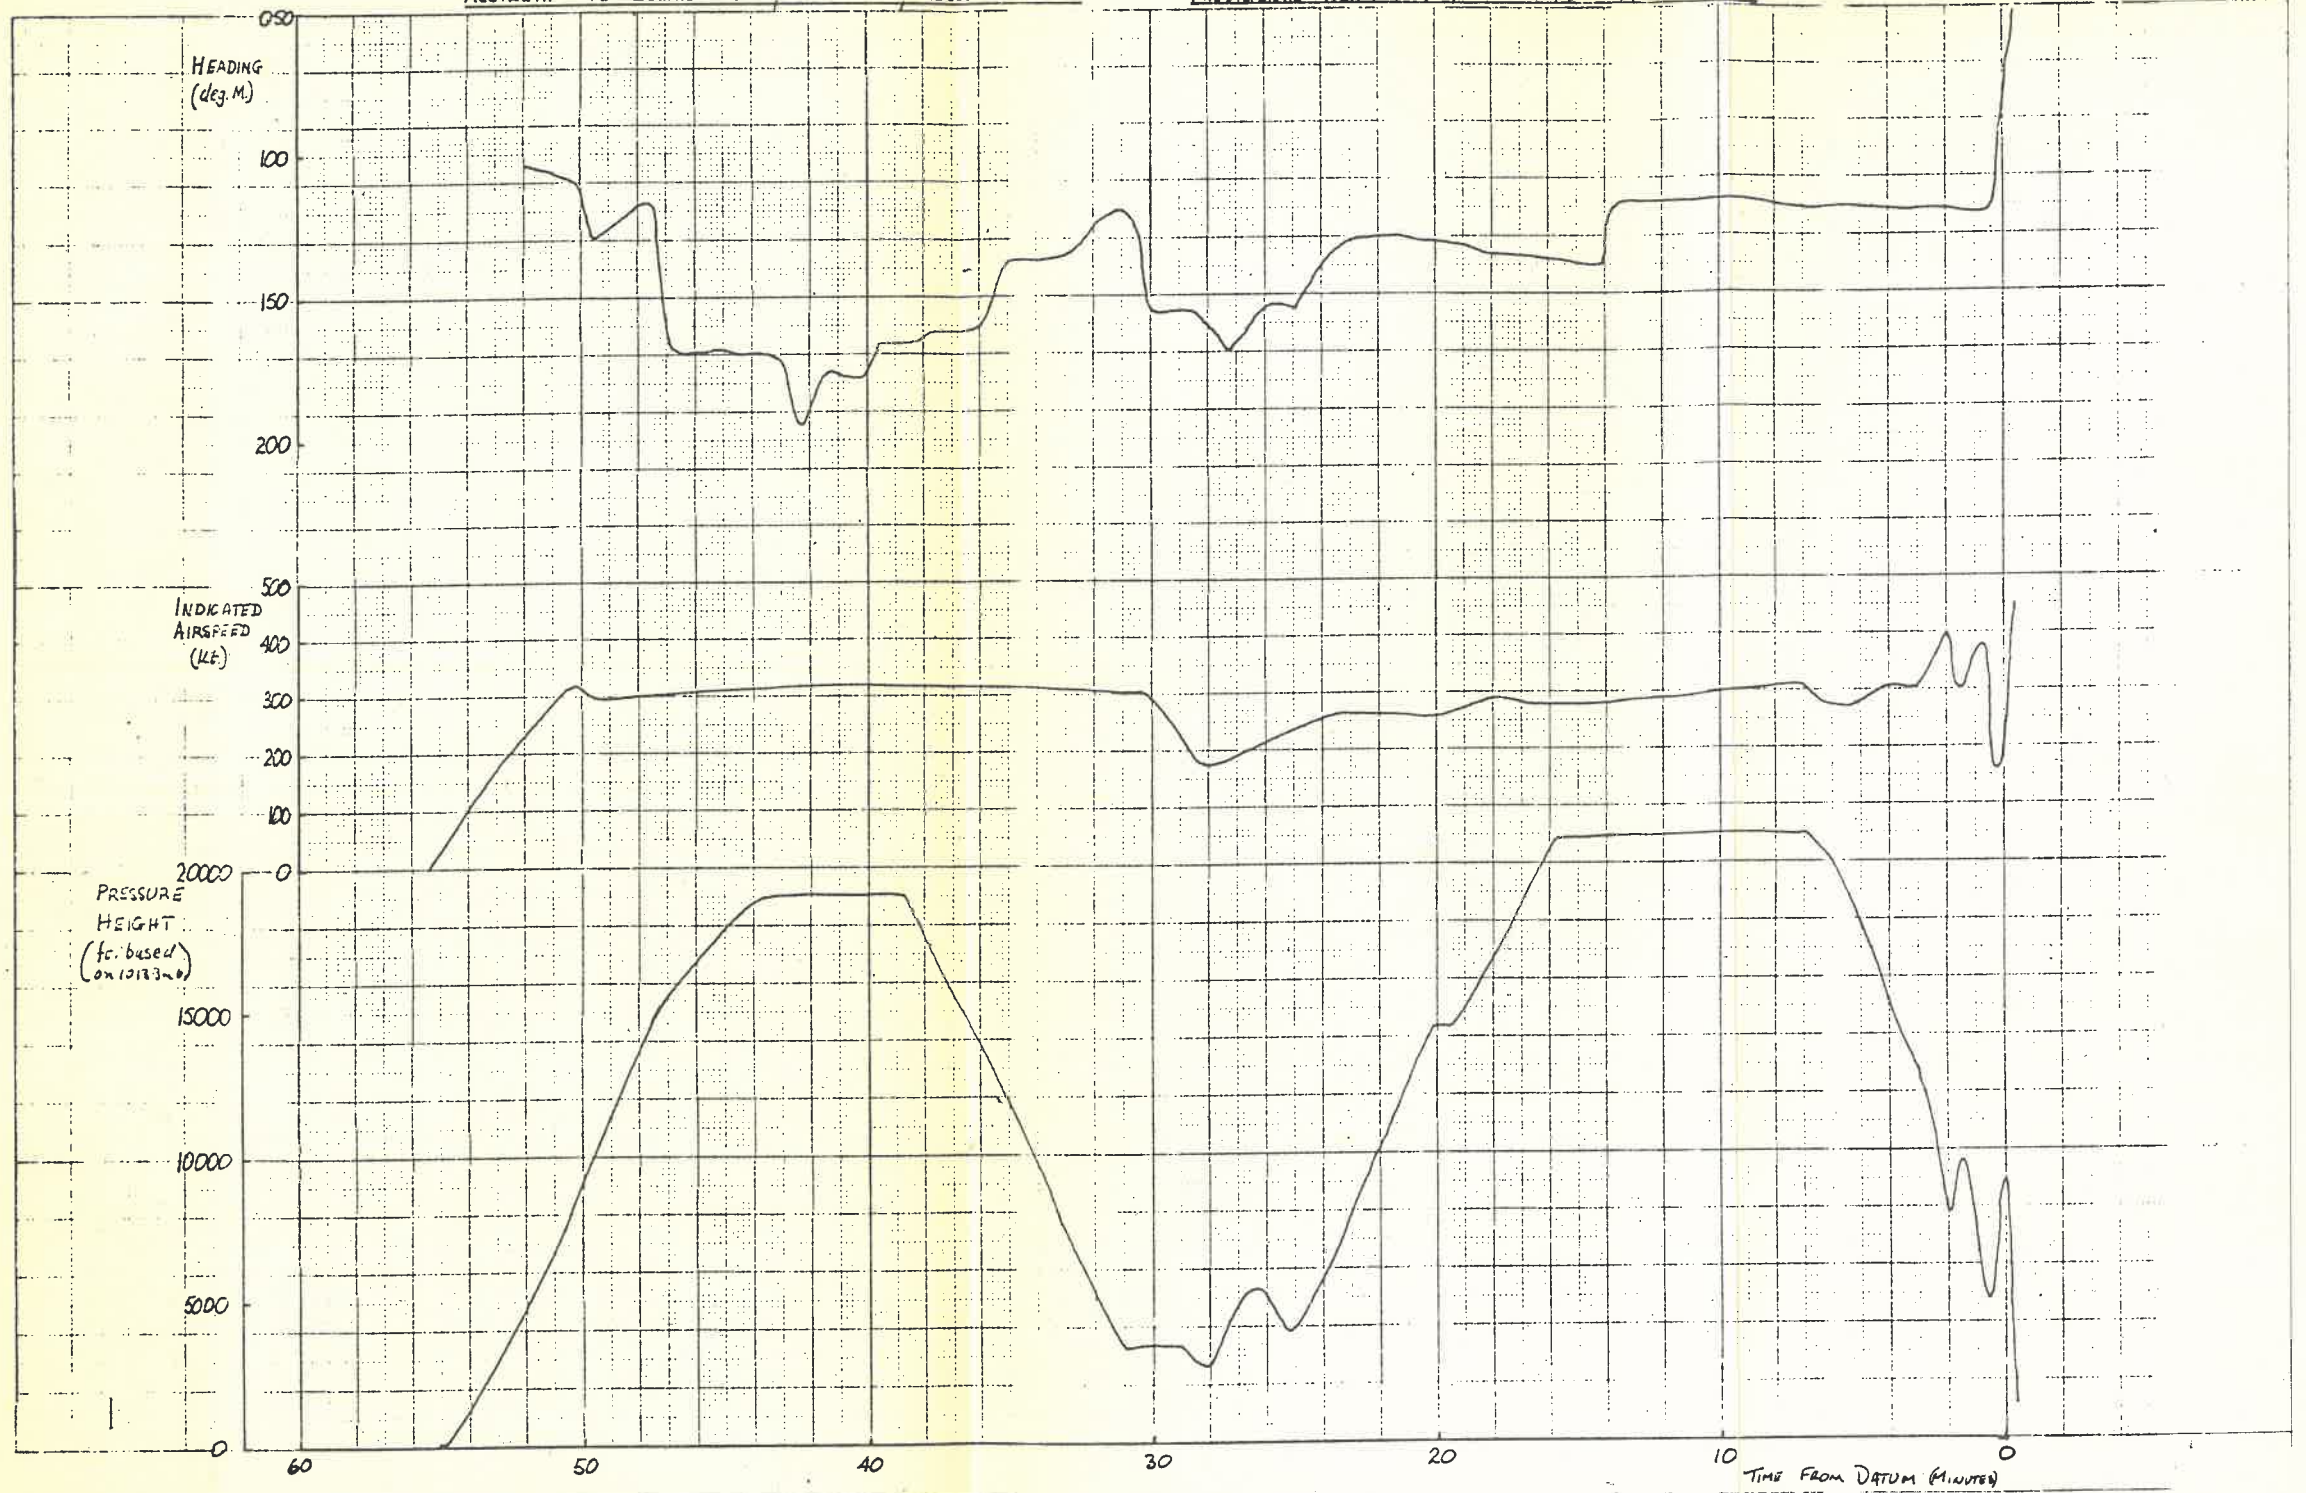
PROVISIONAL F.D.R. DATA & APPROXIMATE FLIGHT PROFILE

Analysis of the FDR read-out confirms that the aircraft took-off from Penang and cruised at flight level 190 for Kuala Lumpur. The flight progressed smoothly with the aircraft progressively descending and then levelling off at 3,000 feet. The FDR indicates that the aircraft began a descent from 3,000 feet to 2,500 feet inbound for Kuala Lumpur.

The aircraft overshot the airfield at 2,500 feet and climbed sharply to 5,000 feet. It descended quickly to 4,000 feet and then established a smooth climb-out to flight level 140.

The FDR then indicates that the aircraft levelled off at flight level 140 for a short while before climbing to flight level 210.

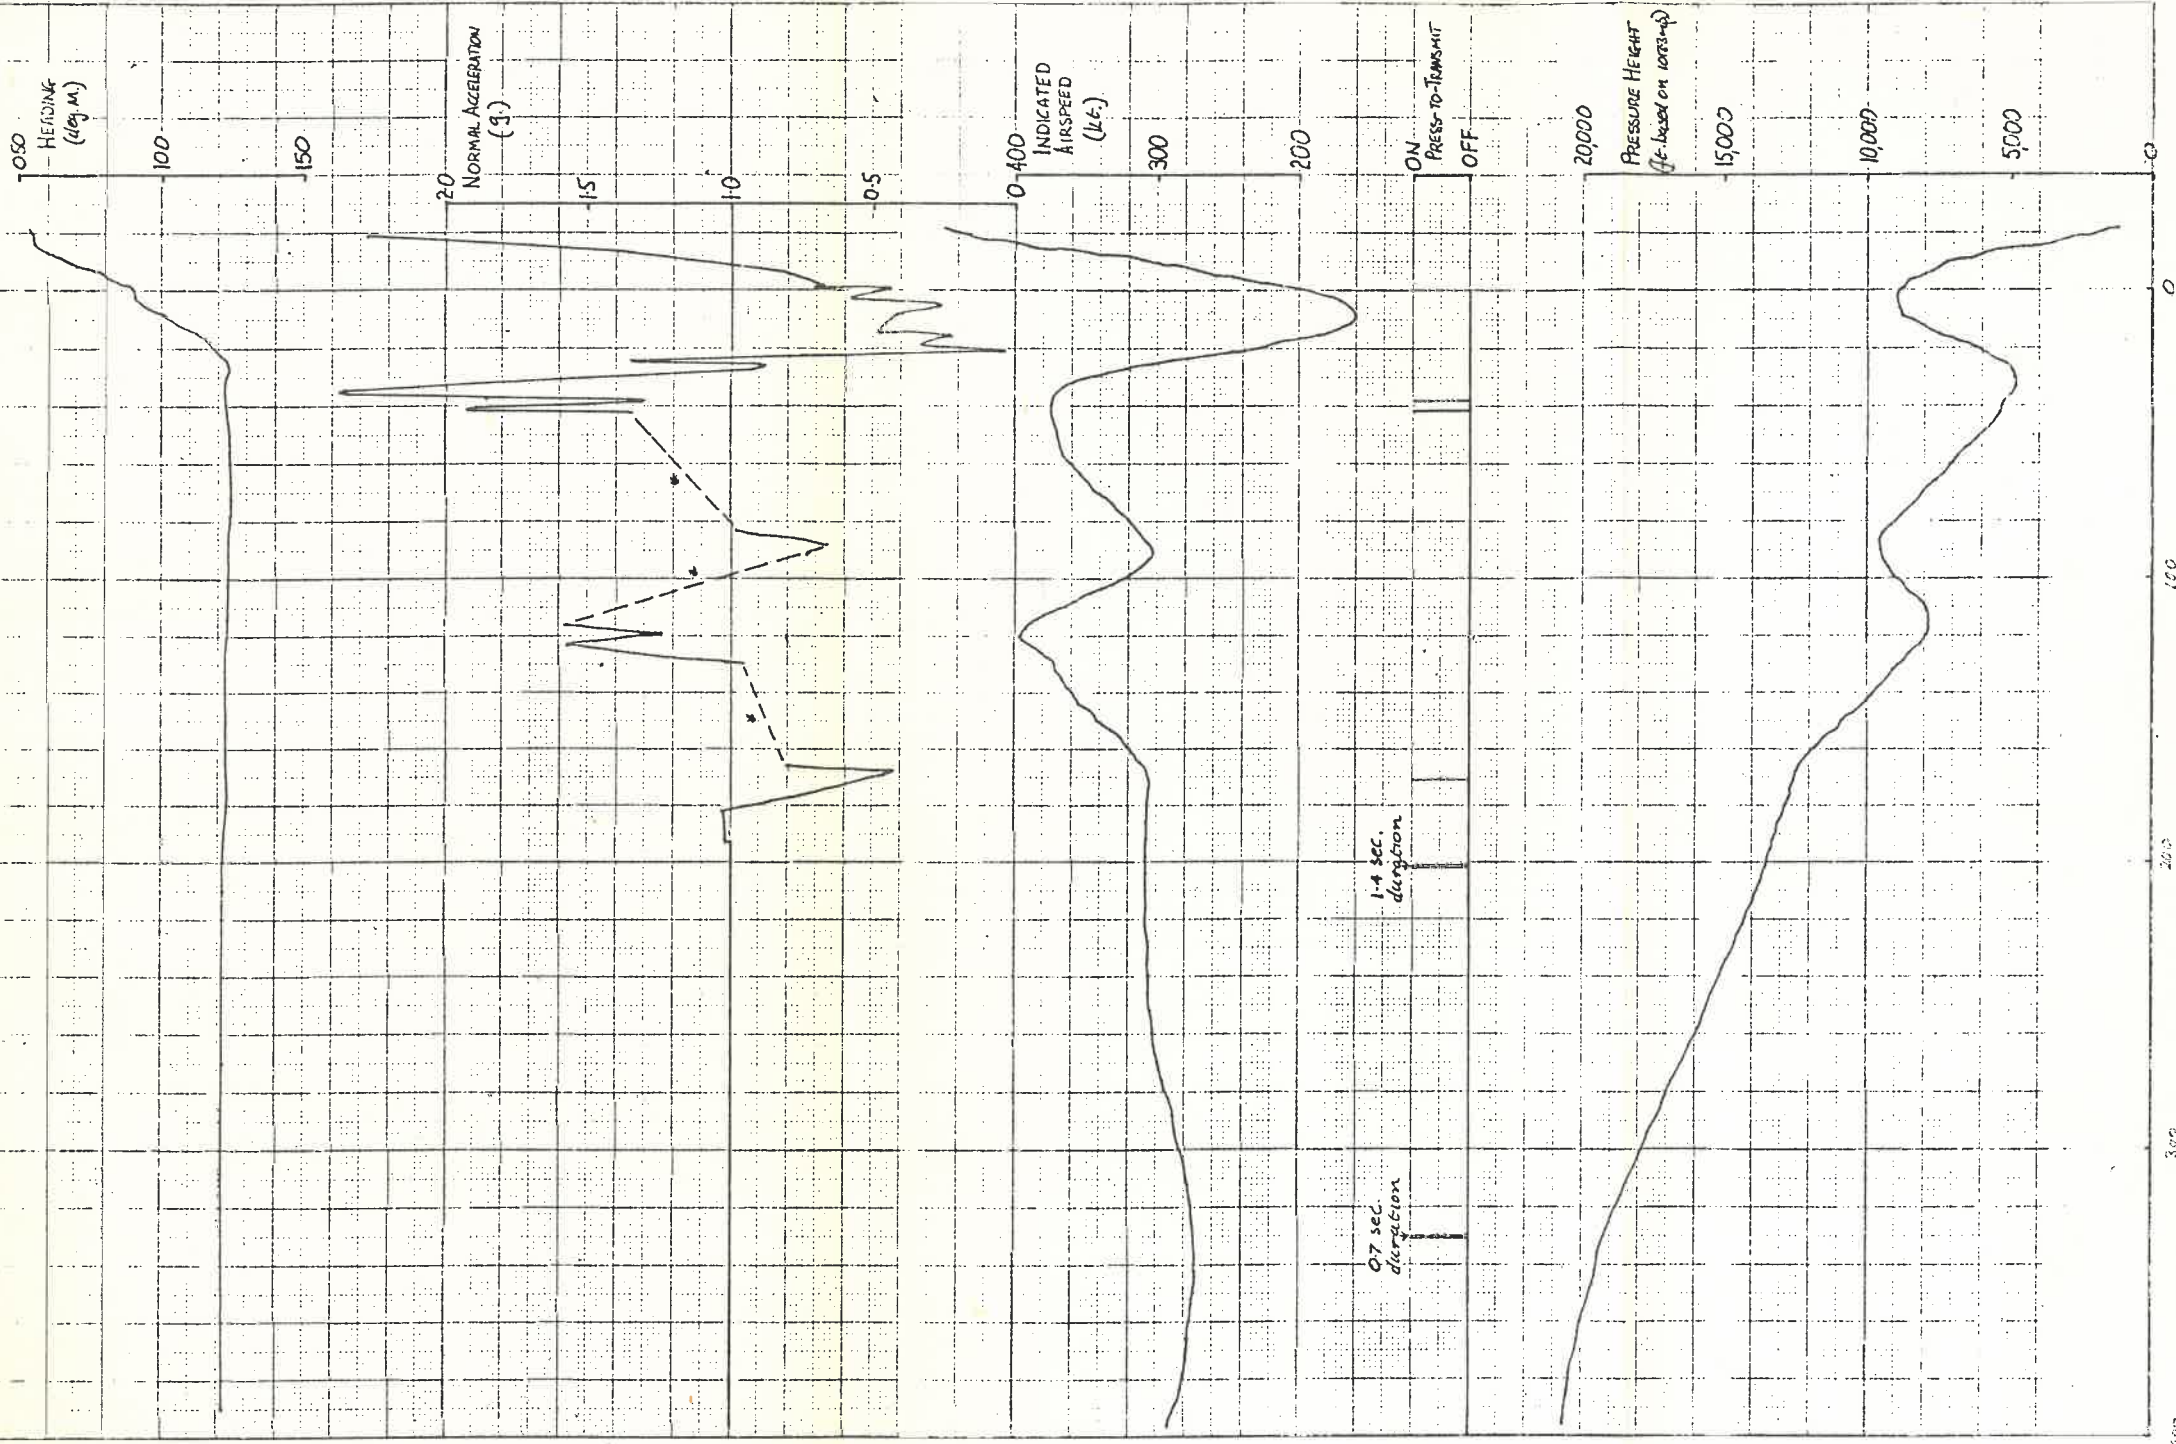
PROVISIONAL FDR DATA (RE'S NOT INCLUDED, NOMINAL GAS USED, NORMAL g (NEEDED FOR CORRECTION AMPLIFIED TO HEADING GAS TO ALLOW FOR AIRCRAFT'S AIRCRAFT SYSTEMS BUT NOT CORRECTED FOR AIRCRAFT'S FINAL DESCENT)

* DASHED LINES INDICATE AREAS WHERE DATA WAS UNOBTAINABLE DUE TO FAIL DAMAGE

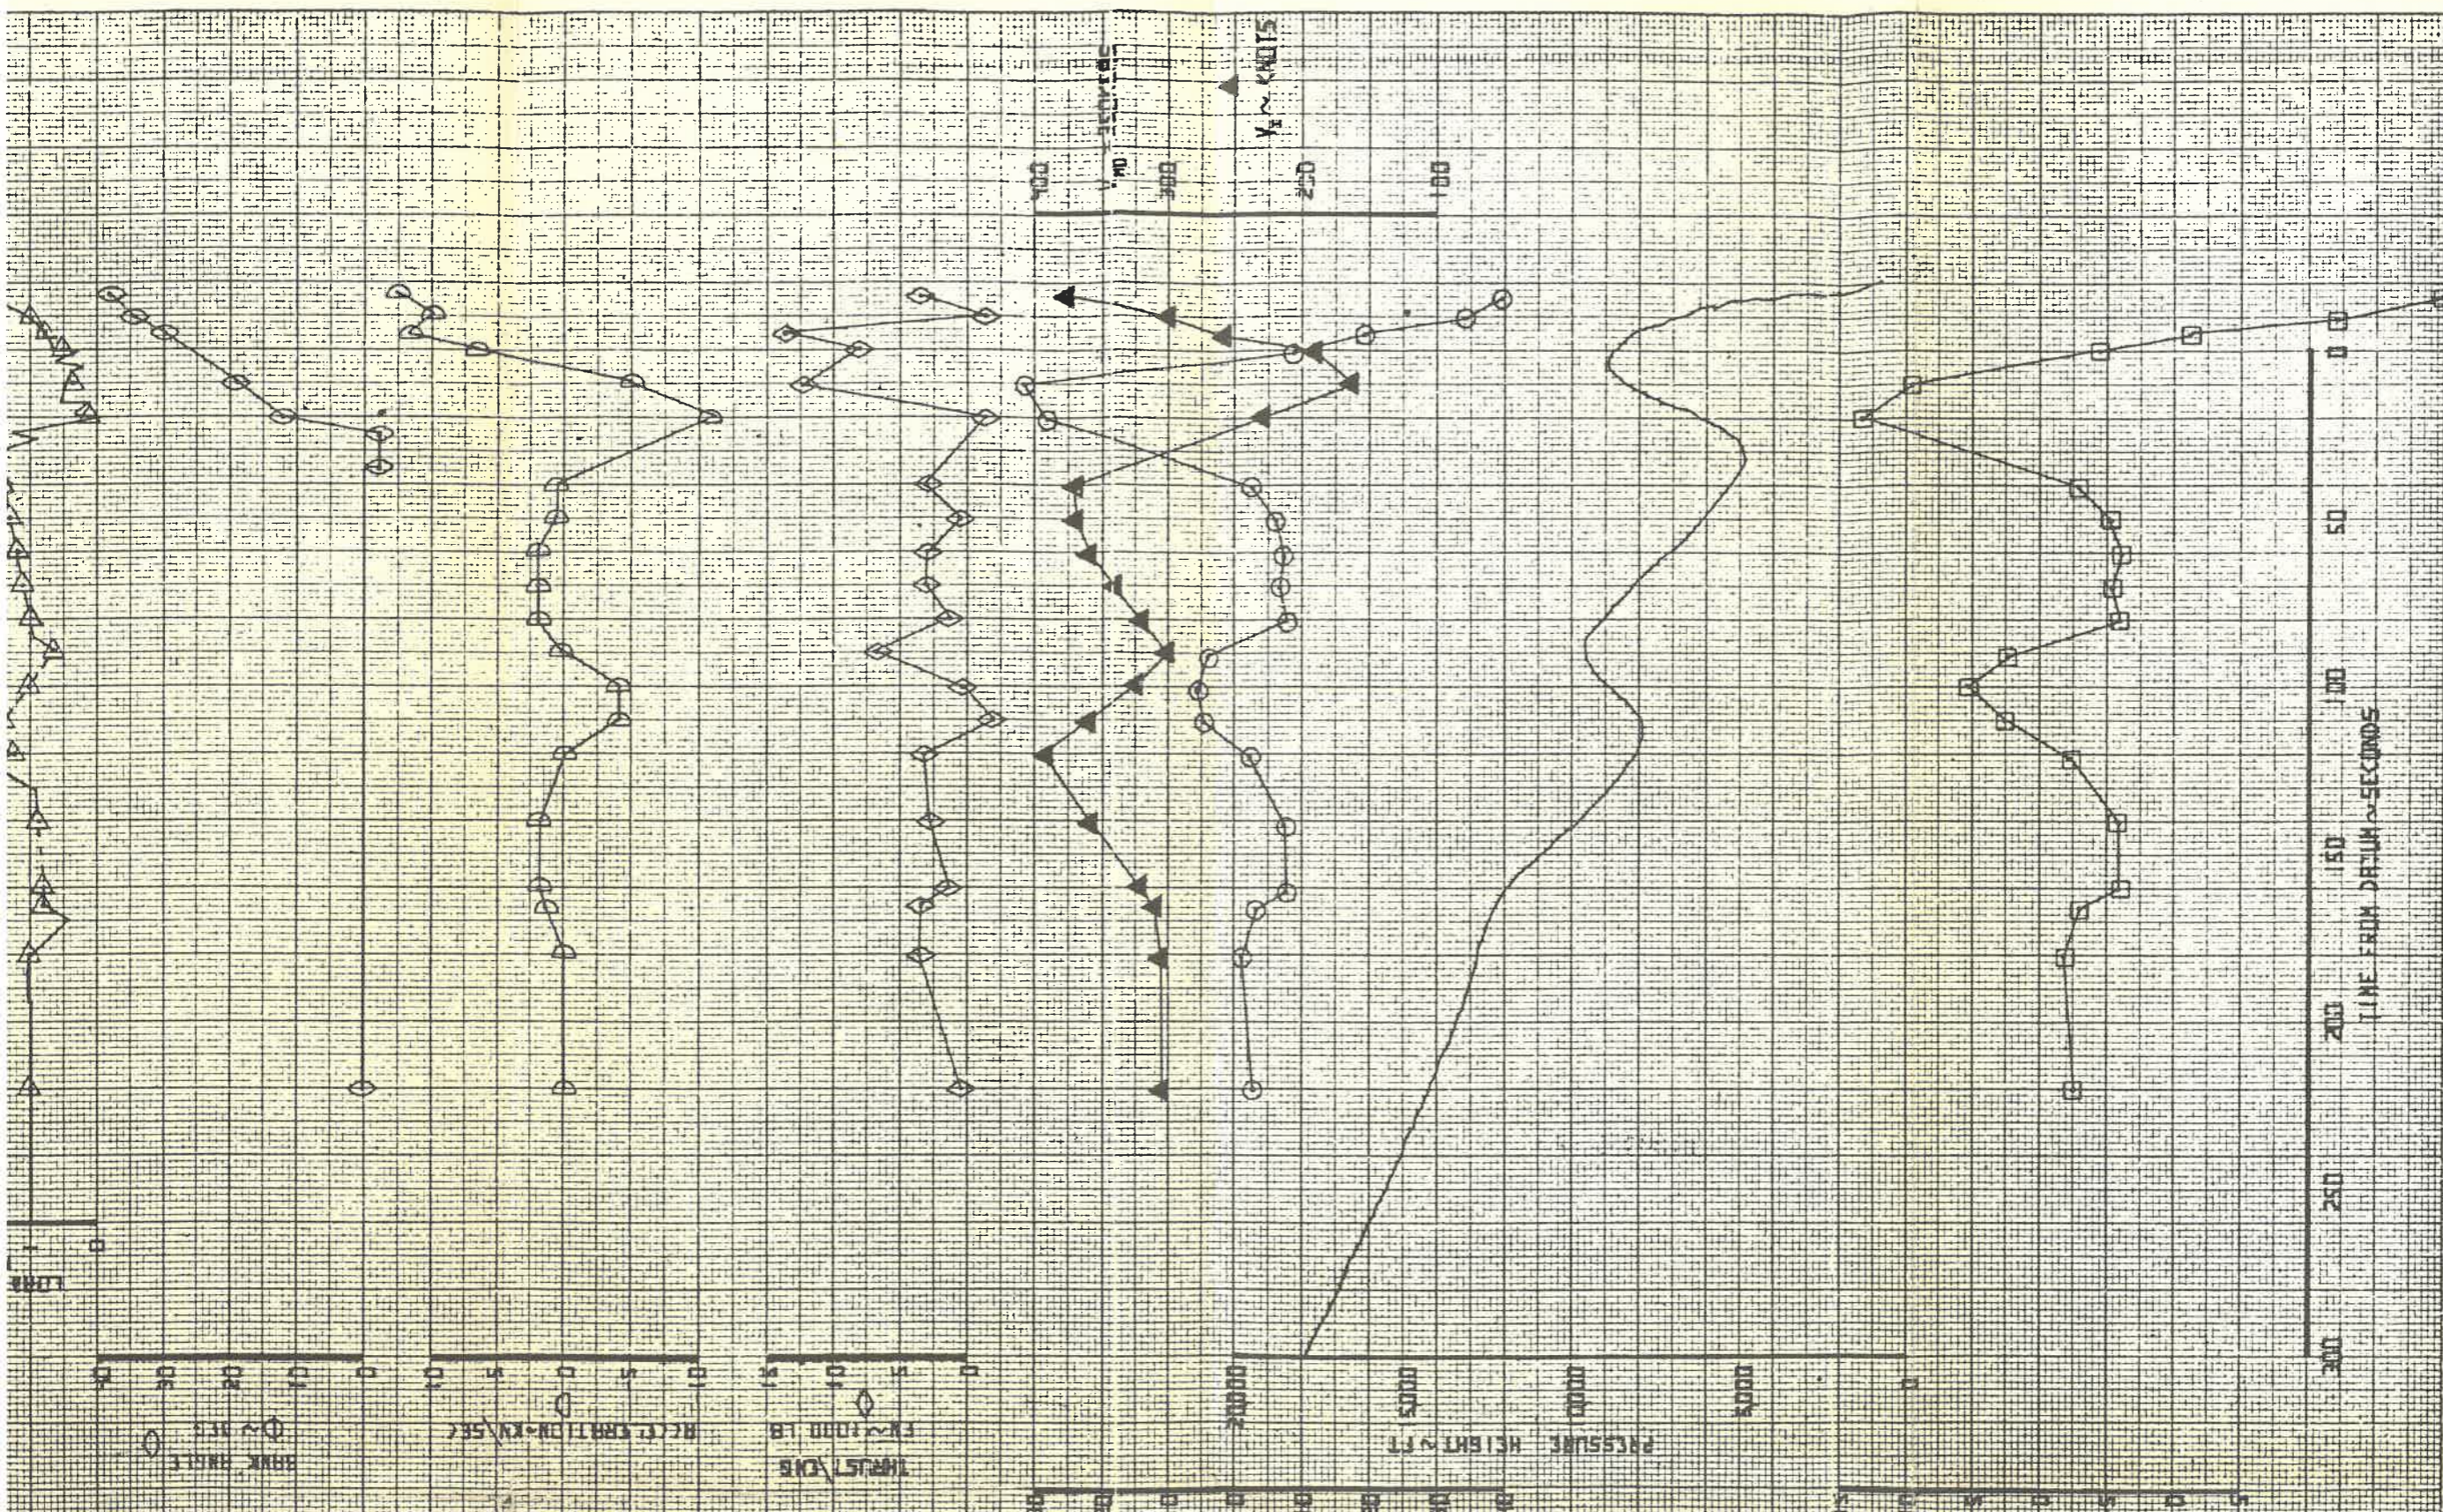
757-246
 FIG 1
 PAGE

From the evaluation of the FDR read-out traces and observation of the computed performance, it appears that the aircraft was responding in a normal manner to some abnormal control inputs that eventually caused the aircraft to enter into an irrecoverable situation.
